Clark County Stream Health Report

Department of
Environmental
Services

2010 Clark County Stream Health Report

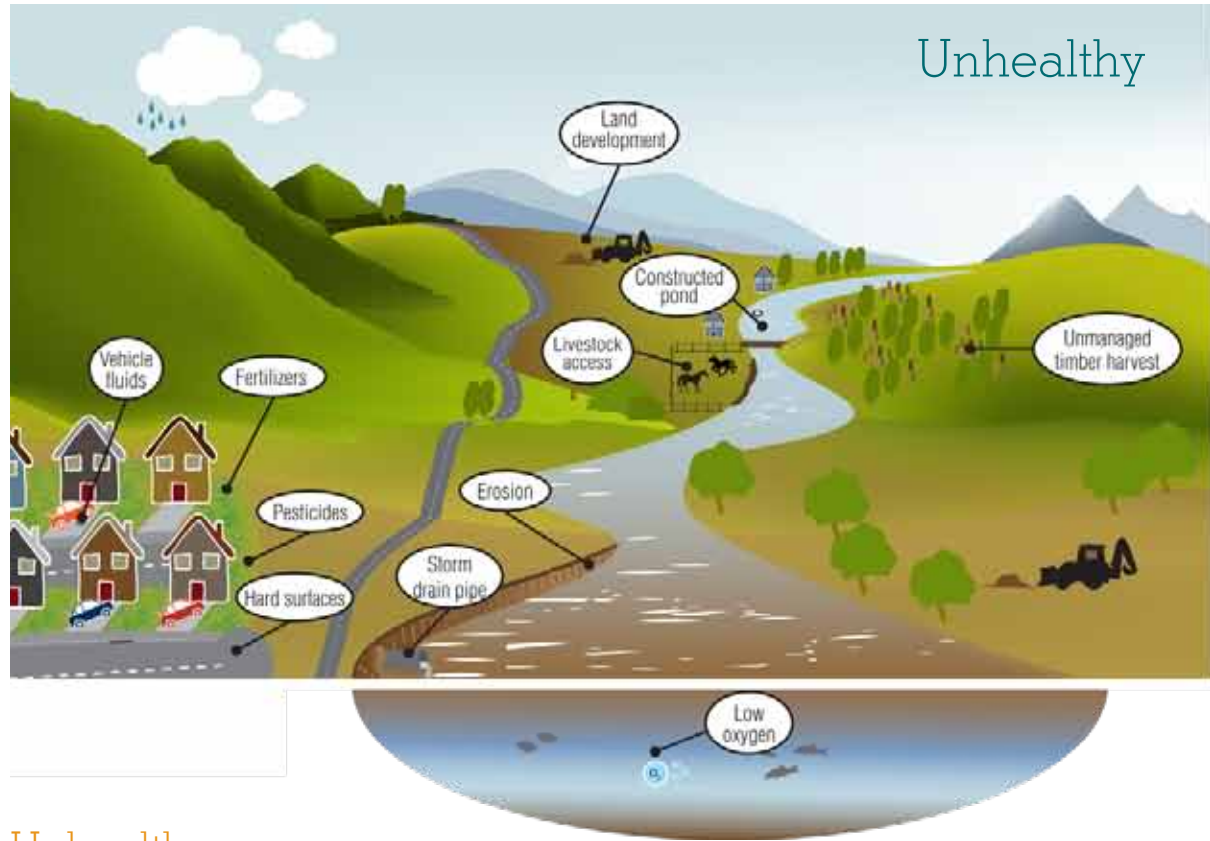
In-channel ponds change stream flows and absorb heat, which harms stream life.

Livestock access adds bacteria and causes bank erosion.

Land development without effective stormwater management increases runoff, which causes erosion and affects water quality.

Unmanaged timber harvest increases runoff and causes erosion.

Fertilizers are plant nutrients that cause algae blooms downstream, which can harm stream life, pets and people.

Hard surfaces such as roads and roofs, and pipes that remove stormwater, increase runoff and cause stream levels to rise quickly. Hard surfaces are especially harmful next to streams.

There is a significant relationship between our streams and the land that surrounds them [Figure 1]. Our activities in the watershed affect the streams that run through them.

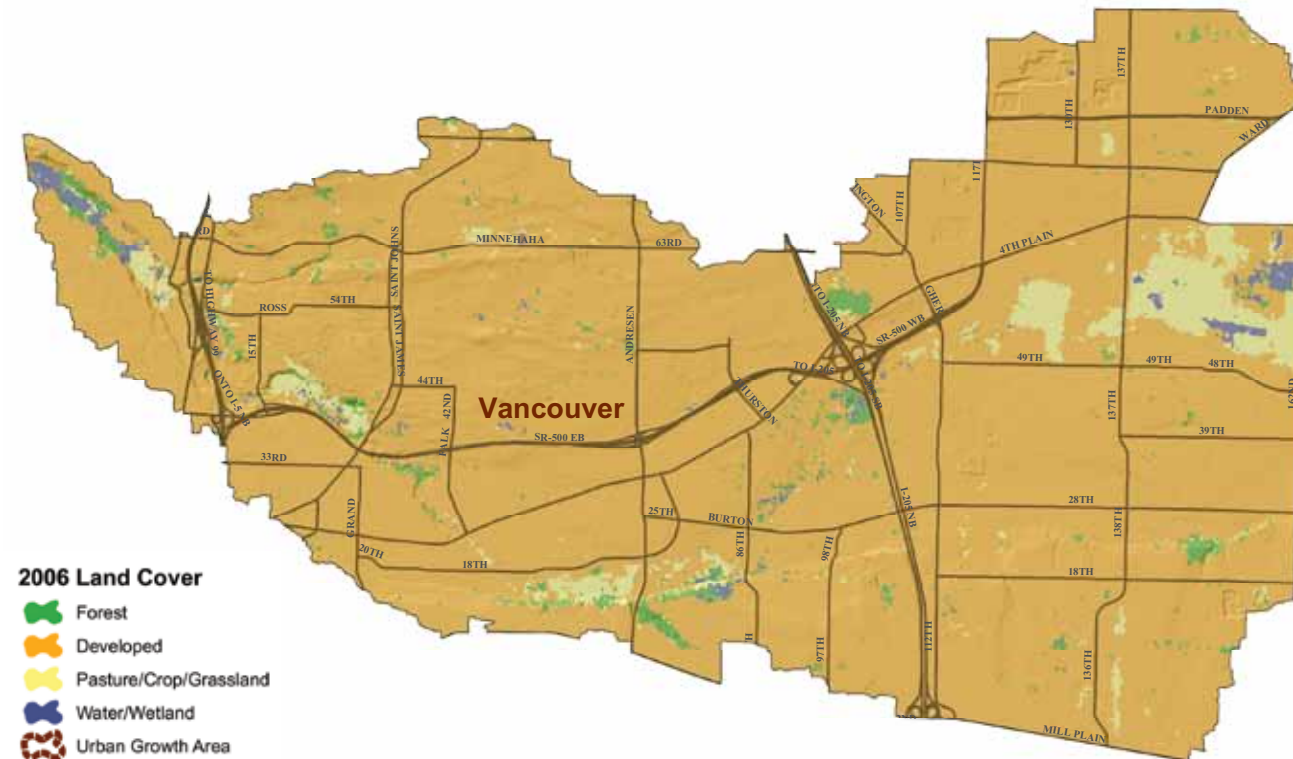
Burnt Bridge Watershed: Stream Health

Burnt Bridge Steam Health Score Card

Subwatershed	Water Quality	Biological Health	Flow	Subwatershed Rating
Lower Burnt Bridge Creek	●	--	--	●
Middle Burnt Bridge Creek	●	--	--	●
Indicator Rating	●			
Overall Watershed Rating:				Poor ●

Data were not collected from the following subwatersheds: Burton Sink and Upper Burnt Bridge Creek

- There are no good or fair ratings
- Historical data suggest Burnt Bridge Creek is the least healthy stream in Clark County
- Washington Department of Ecology is developing a state Water Cleanup Plan for bacteria, temperature, dissolved oxygen, and pH

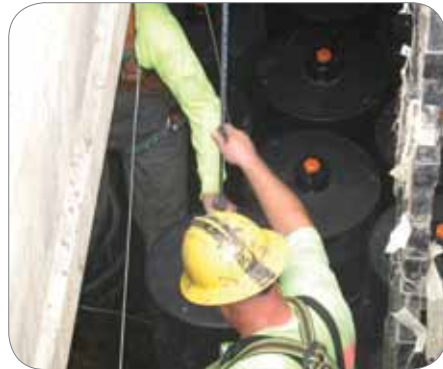
Replacing stormwater filters

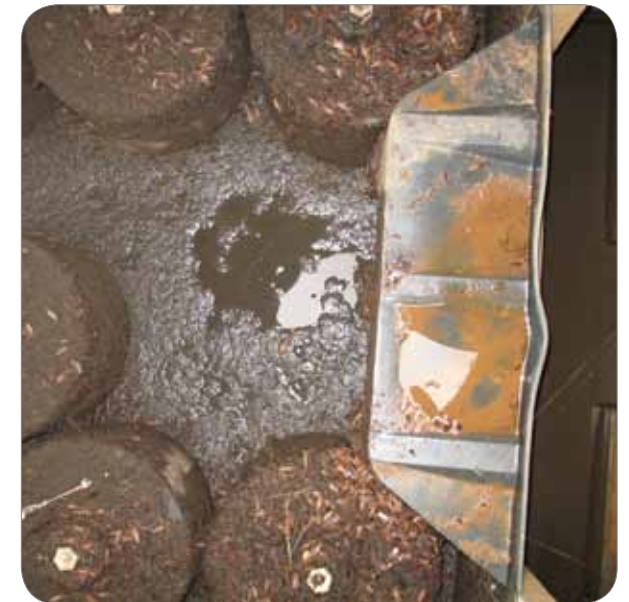
A sediment-filled stormwater vault
